World Trade Center Investigation Objectives

- Determine:
 - why and how the WTC Towers collapsed following the initial impact of the aircraft, and
 - why and how the 47-story WTC 7 collapsed
- Determine why the numbers of injuries and fatalities were so low or high depending on location, including technical aspects of fire protection, occupant behavior, evacuation, and emergency response
- Determine the procedures and practices that were used in the design, construction, operation, and maintenance of the WTC buildings
- **Identify, as specifically as possible, areas in current national building and fire model codes, standards, and practices that warrant revision**

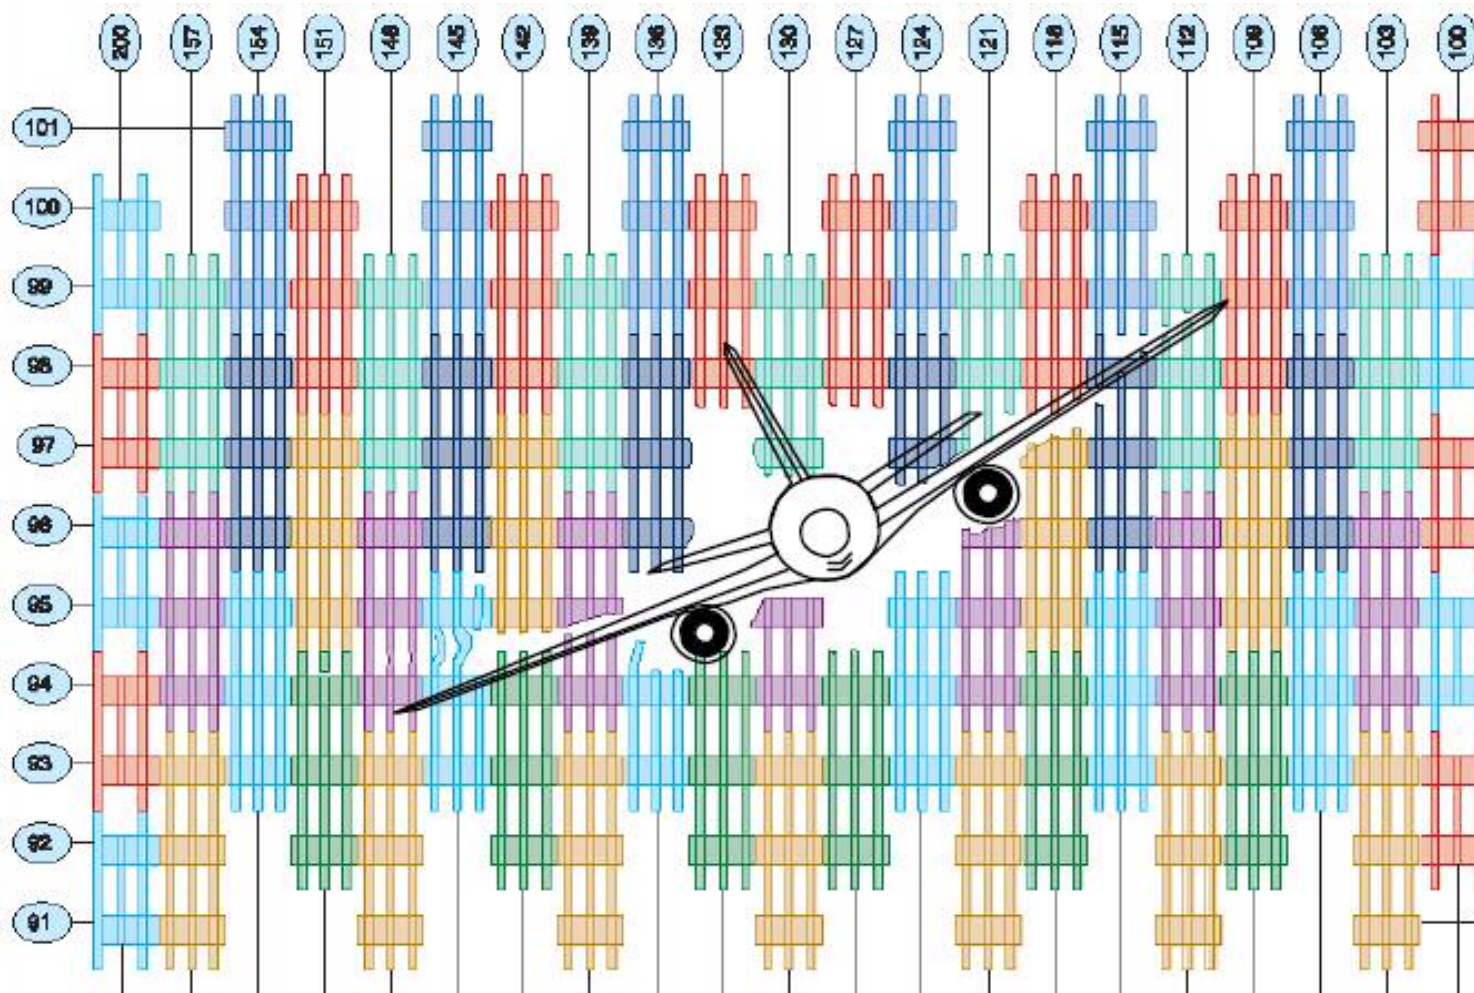
Figure 15(a). The outline of the airplane superposed on the hole driven in the exterior wall of the North Tower

Damage to the exterior columns of the North Tower immediately after the impact.

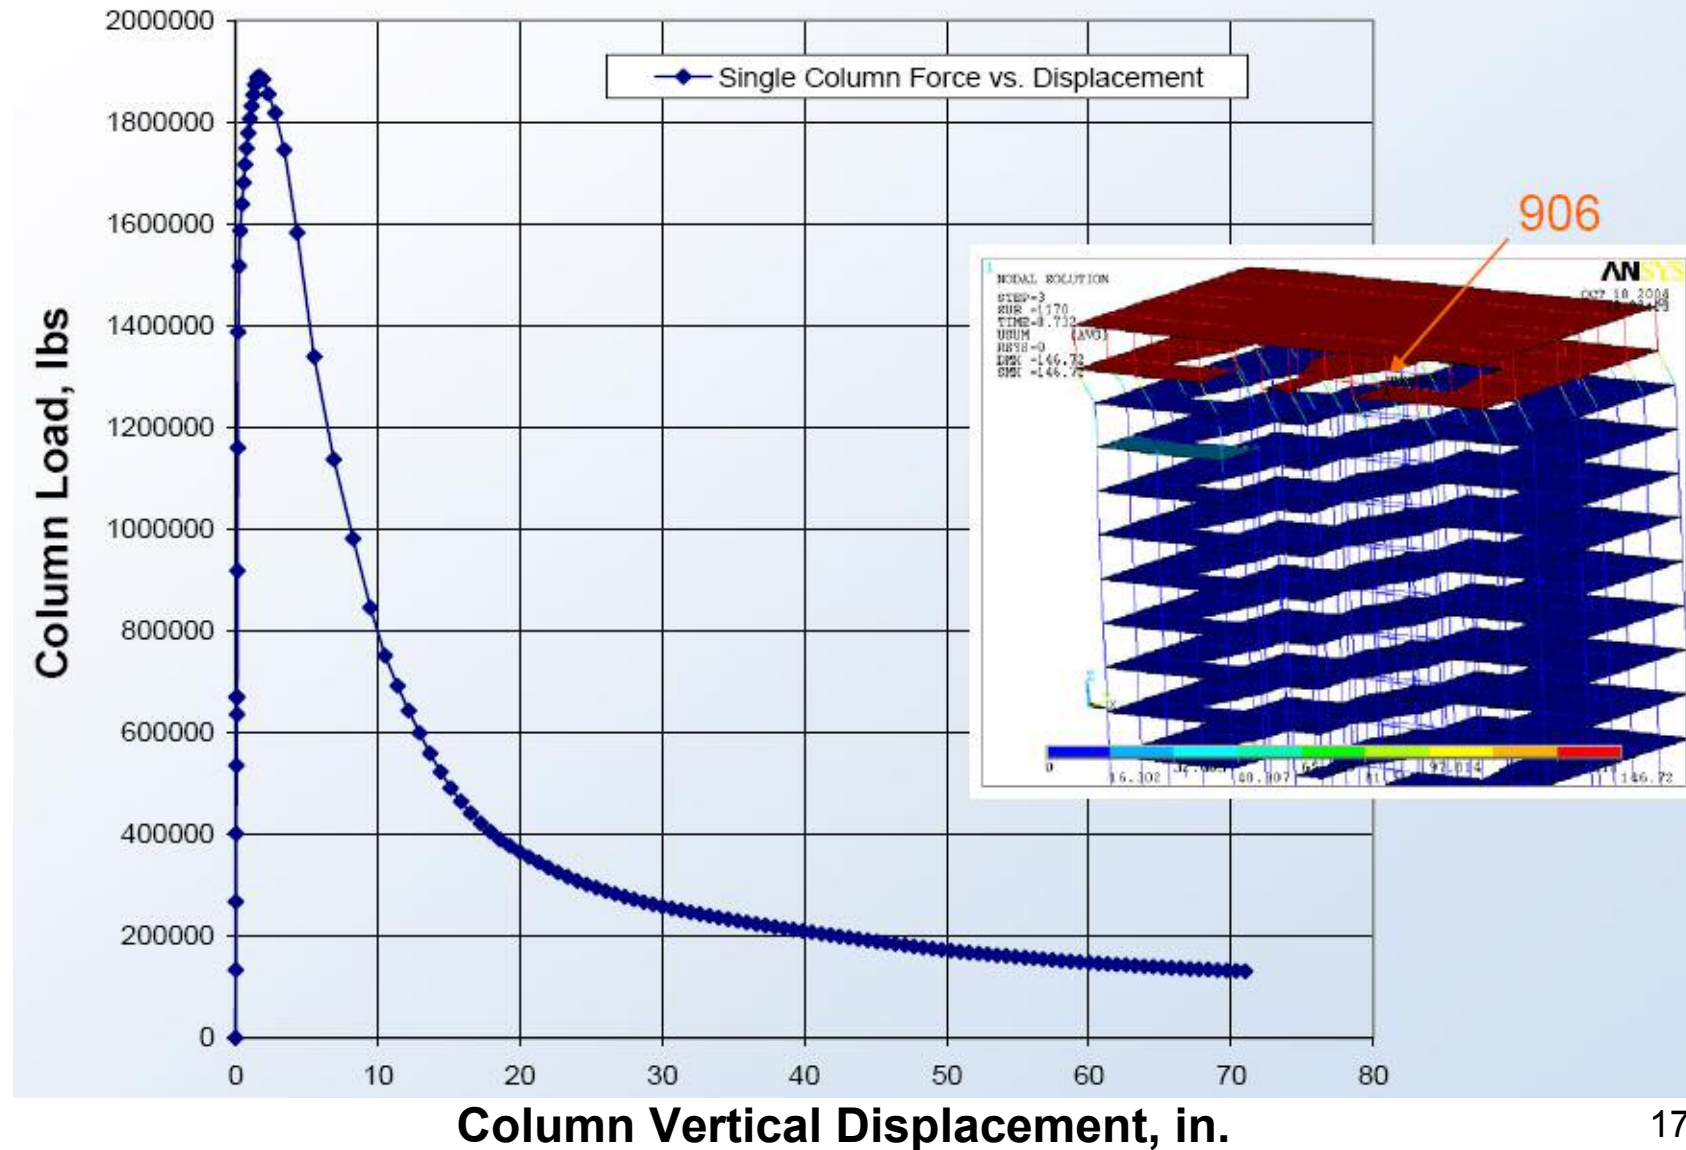
Buckling of Core Column 906 at Room Temperature Due to Displacement-Induced Collapse Analysis

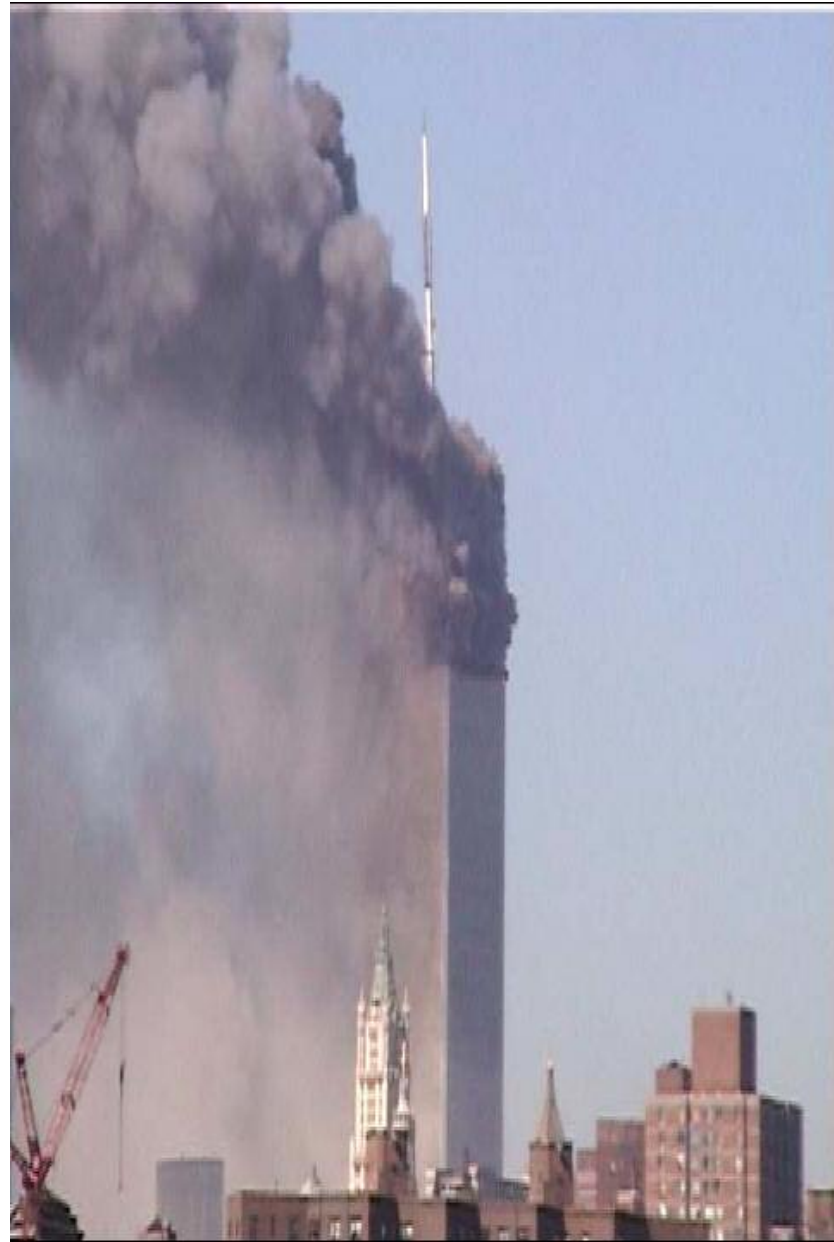
WTC 1 Collapse

Initiation of global collapse was first observed by the tilting of building sections above the impact regions of both WTC towers.

WTC 1 tilted to the south in this view from the northeast.

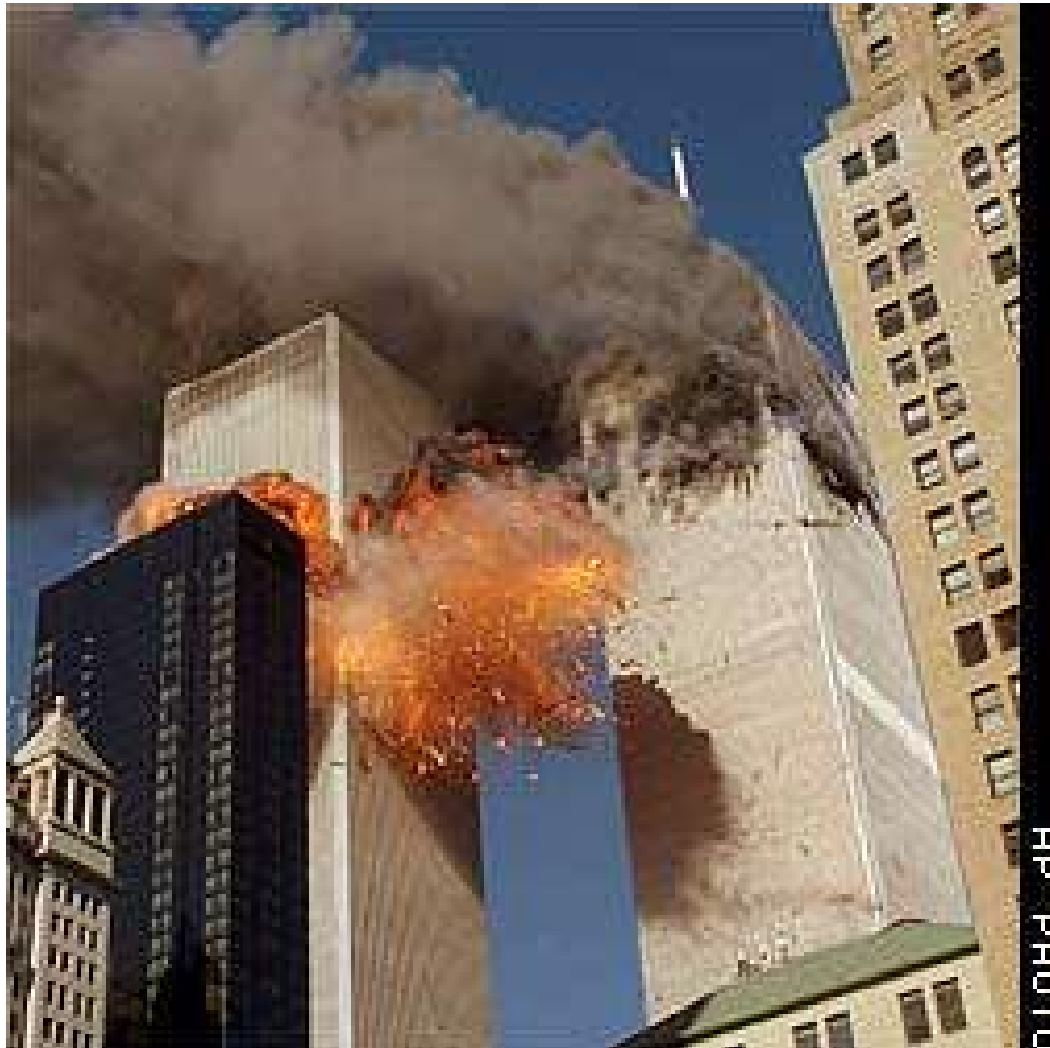
Fireball From Impact on South Tower

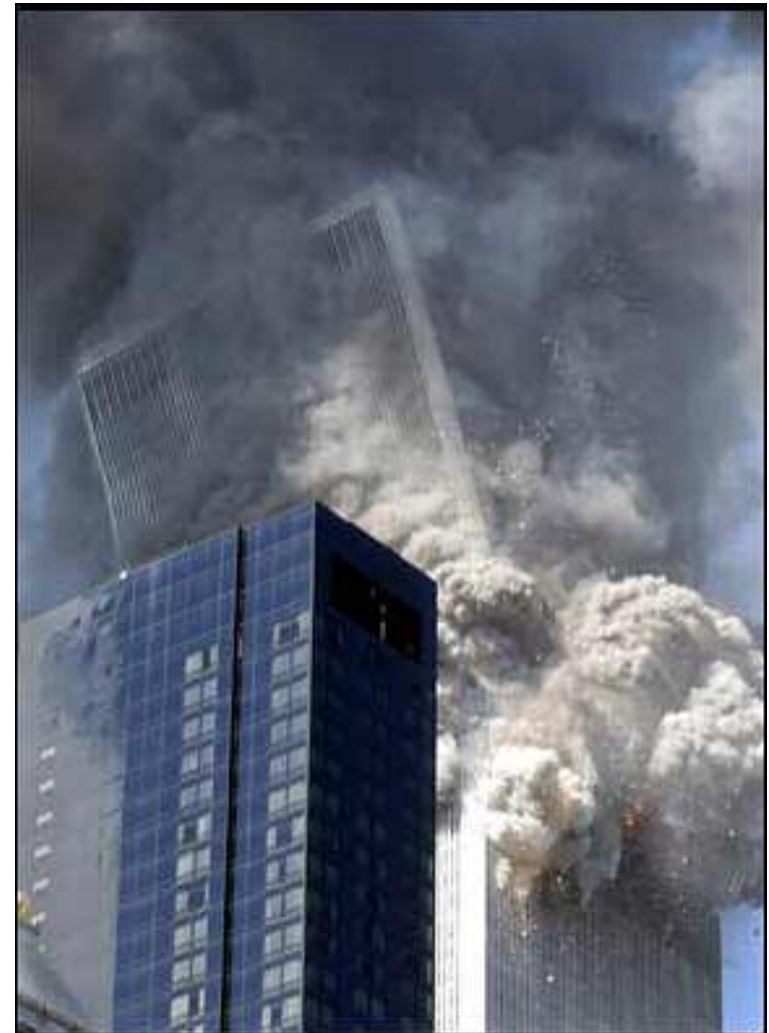
Top of South Tower Collapsing

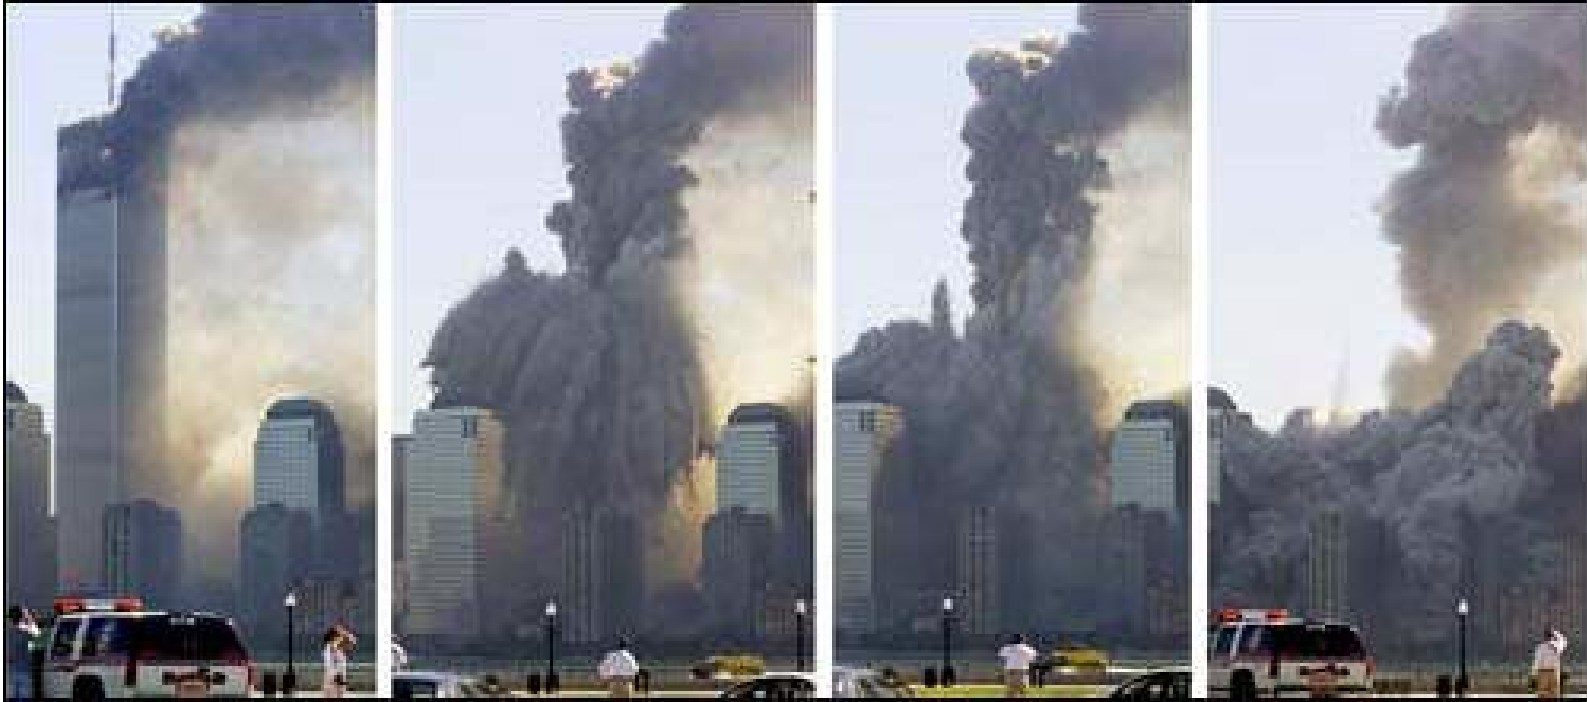
Sequence of Collapse of North Tower

Interconnection between one or more floors and the perimeter frame failed near the top of the building.

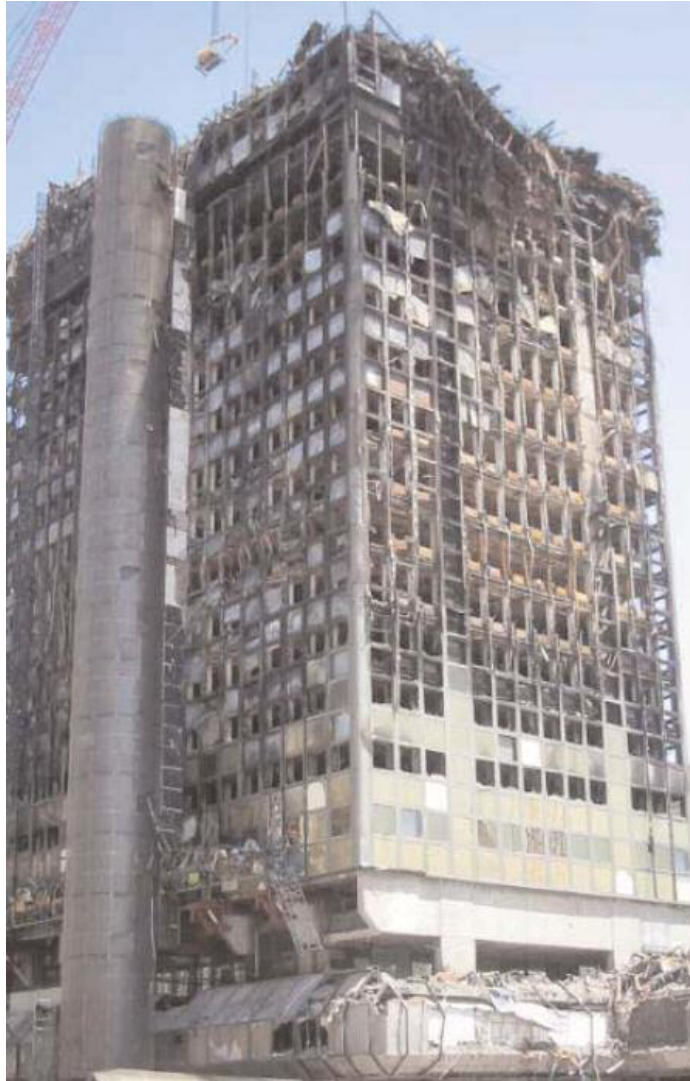
Initial investigations into the recent fire that devastated the Windsor Torre in Madrid again highlight the problem of steel's performance in fire. Failure was limited to the perimeter steel frame whereas the internal concrete frame survived complete burnout with no collapse.

The fire which started on the 21st floor of the 32-storey building quickly spread due to lack of fire stops between the curtain wall façade and the concrete floor slabs. Designed and built in the 1970s, the tower was built using traditional methods of design. Extensive refurbishment was under way at the time of the fire. Part of the refurbishment programme was to bring the building's fire standards up to date with the installation of a range of active fire prevention and resistance measures.

Failure of the structure happened with the collapse of the steel perimeter columns which resulted in the floor slabs collapsing as the edge support was taken away. The massive concrete transfer slab at the 20th floor prevented further progressive failure. However, as the debris fell the cladding below was smashed and the fire spread to lower floors.

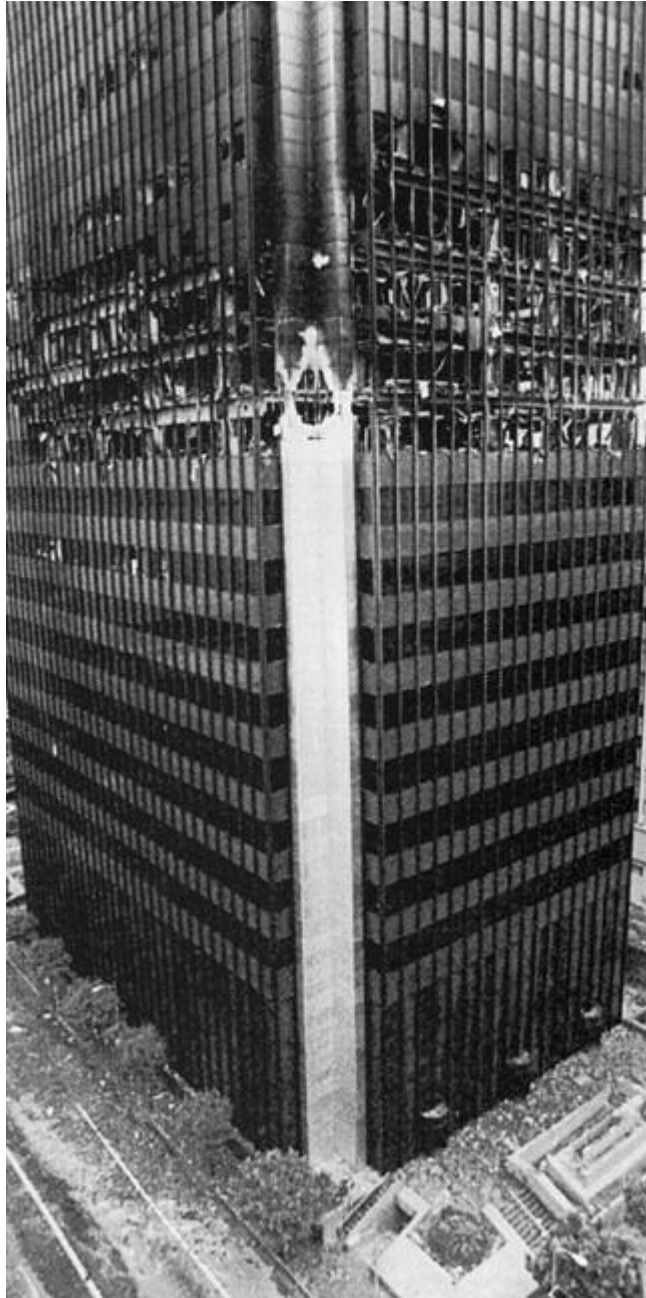
Interstate Bank Building Fire Los Angeles, California (May 4, 1988)

Occupancy	62-story high-rise office building
Construction	Steel frame; exterior of glass and aluminum Unusually good application of fire resistive coating helped maintain structural integrity in fire
Delayed ReportingBuilding	<p>security and maintenance personnel delayed notifying Fire Department for 15 minutes after first evidence of fire.Smoke detectors on several floors had been activated and reset a number of times before reporting to Fire Department.</p> <p>A maintenance employee died while trying to investigate source of alarms prior to calling Fire Department.</p>
Automatic Fire Sprinklers	Sprinkler system was installed in 90 percent of the building, including on fire floors; valves controlling the systems had been closed, awaiting installation of water-flow alarms.
Interior Design and Contents	Large open area with readily combustible contents contributed to quick fire growth.
System Failures	<p>Main fire pumps had been shut down, reducing available water pressure for initial attack.Radio communications were overtaxed and disrupted by building's steel frame.Fire and water damaged telephonecircuits making them unusable.Sound-powered emergency phone system in building was ineffective.</p> <p style="text-align: right;">29</p>

The fire originated in an open-plan office area in the southeast quadrant of the 12th floor.

The cause is thought to be electrical in origin, but the precise source of ignition was not determined.

The fire extended to the entire open area and several office enclosures to fully involve the 12th floor, except for the passenger elevator lobby, which was protected by automatic closing fire doors

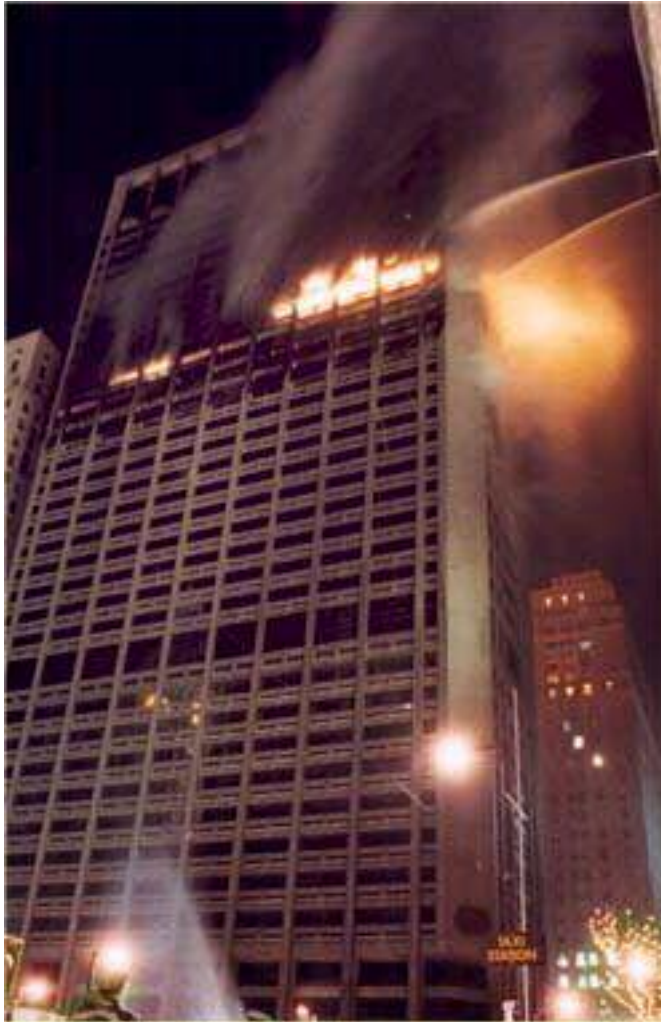
One Meridien Plaza *Philadelphia, Pennsylvania*

Saturday, 23 February 1991, linseed oil-soaked rags left behind by a cleaning crew burst into flames on the 22nd floor of the 38-story One Meridian Plaza in downtown Philadelphia. The fire quickly spread, unimpeded by fire sprinklers, throughout the 22nd floor and then upward.

The twelve-alarm fire burned for 18 hours. The extreme heat caused window glass and frames to melt and concrete floor slabs and steel beams to buckle and sag dramatically.

Large shards of window glass fell from the facade, cutting through fire hoses on the ground around the building. Three firefighters were trapped on a fully engulfed floor, and efforts to rescue them failed.
